State of Oregon
Department of Environmental Quality Memorandum

Subject: Schnitzer Investment Corp. Doane Lake Property File ECSI #395
Proposed Source Control Decision-Determination that Source Control Measure
Satisfactorily Performed.

Attachment A
**Doane Lake Cap Inspection Report
Photograph Log**

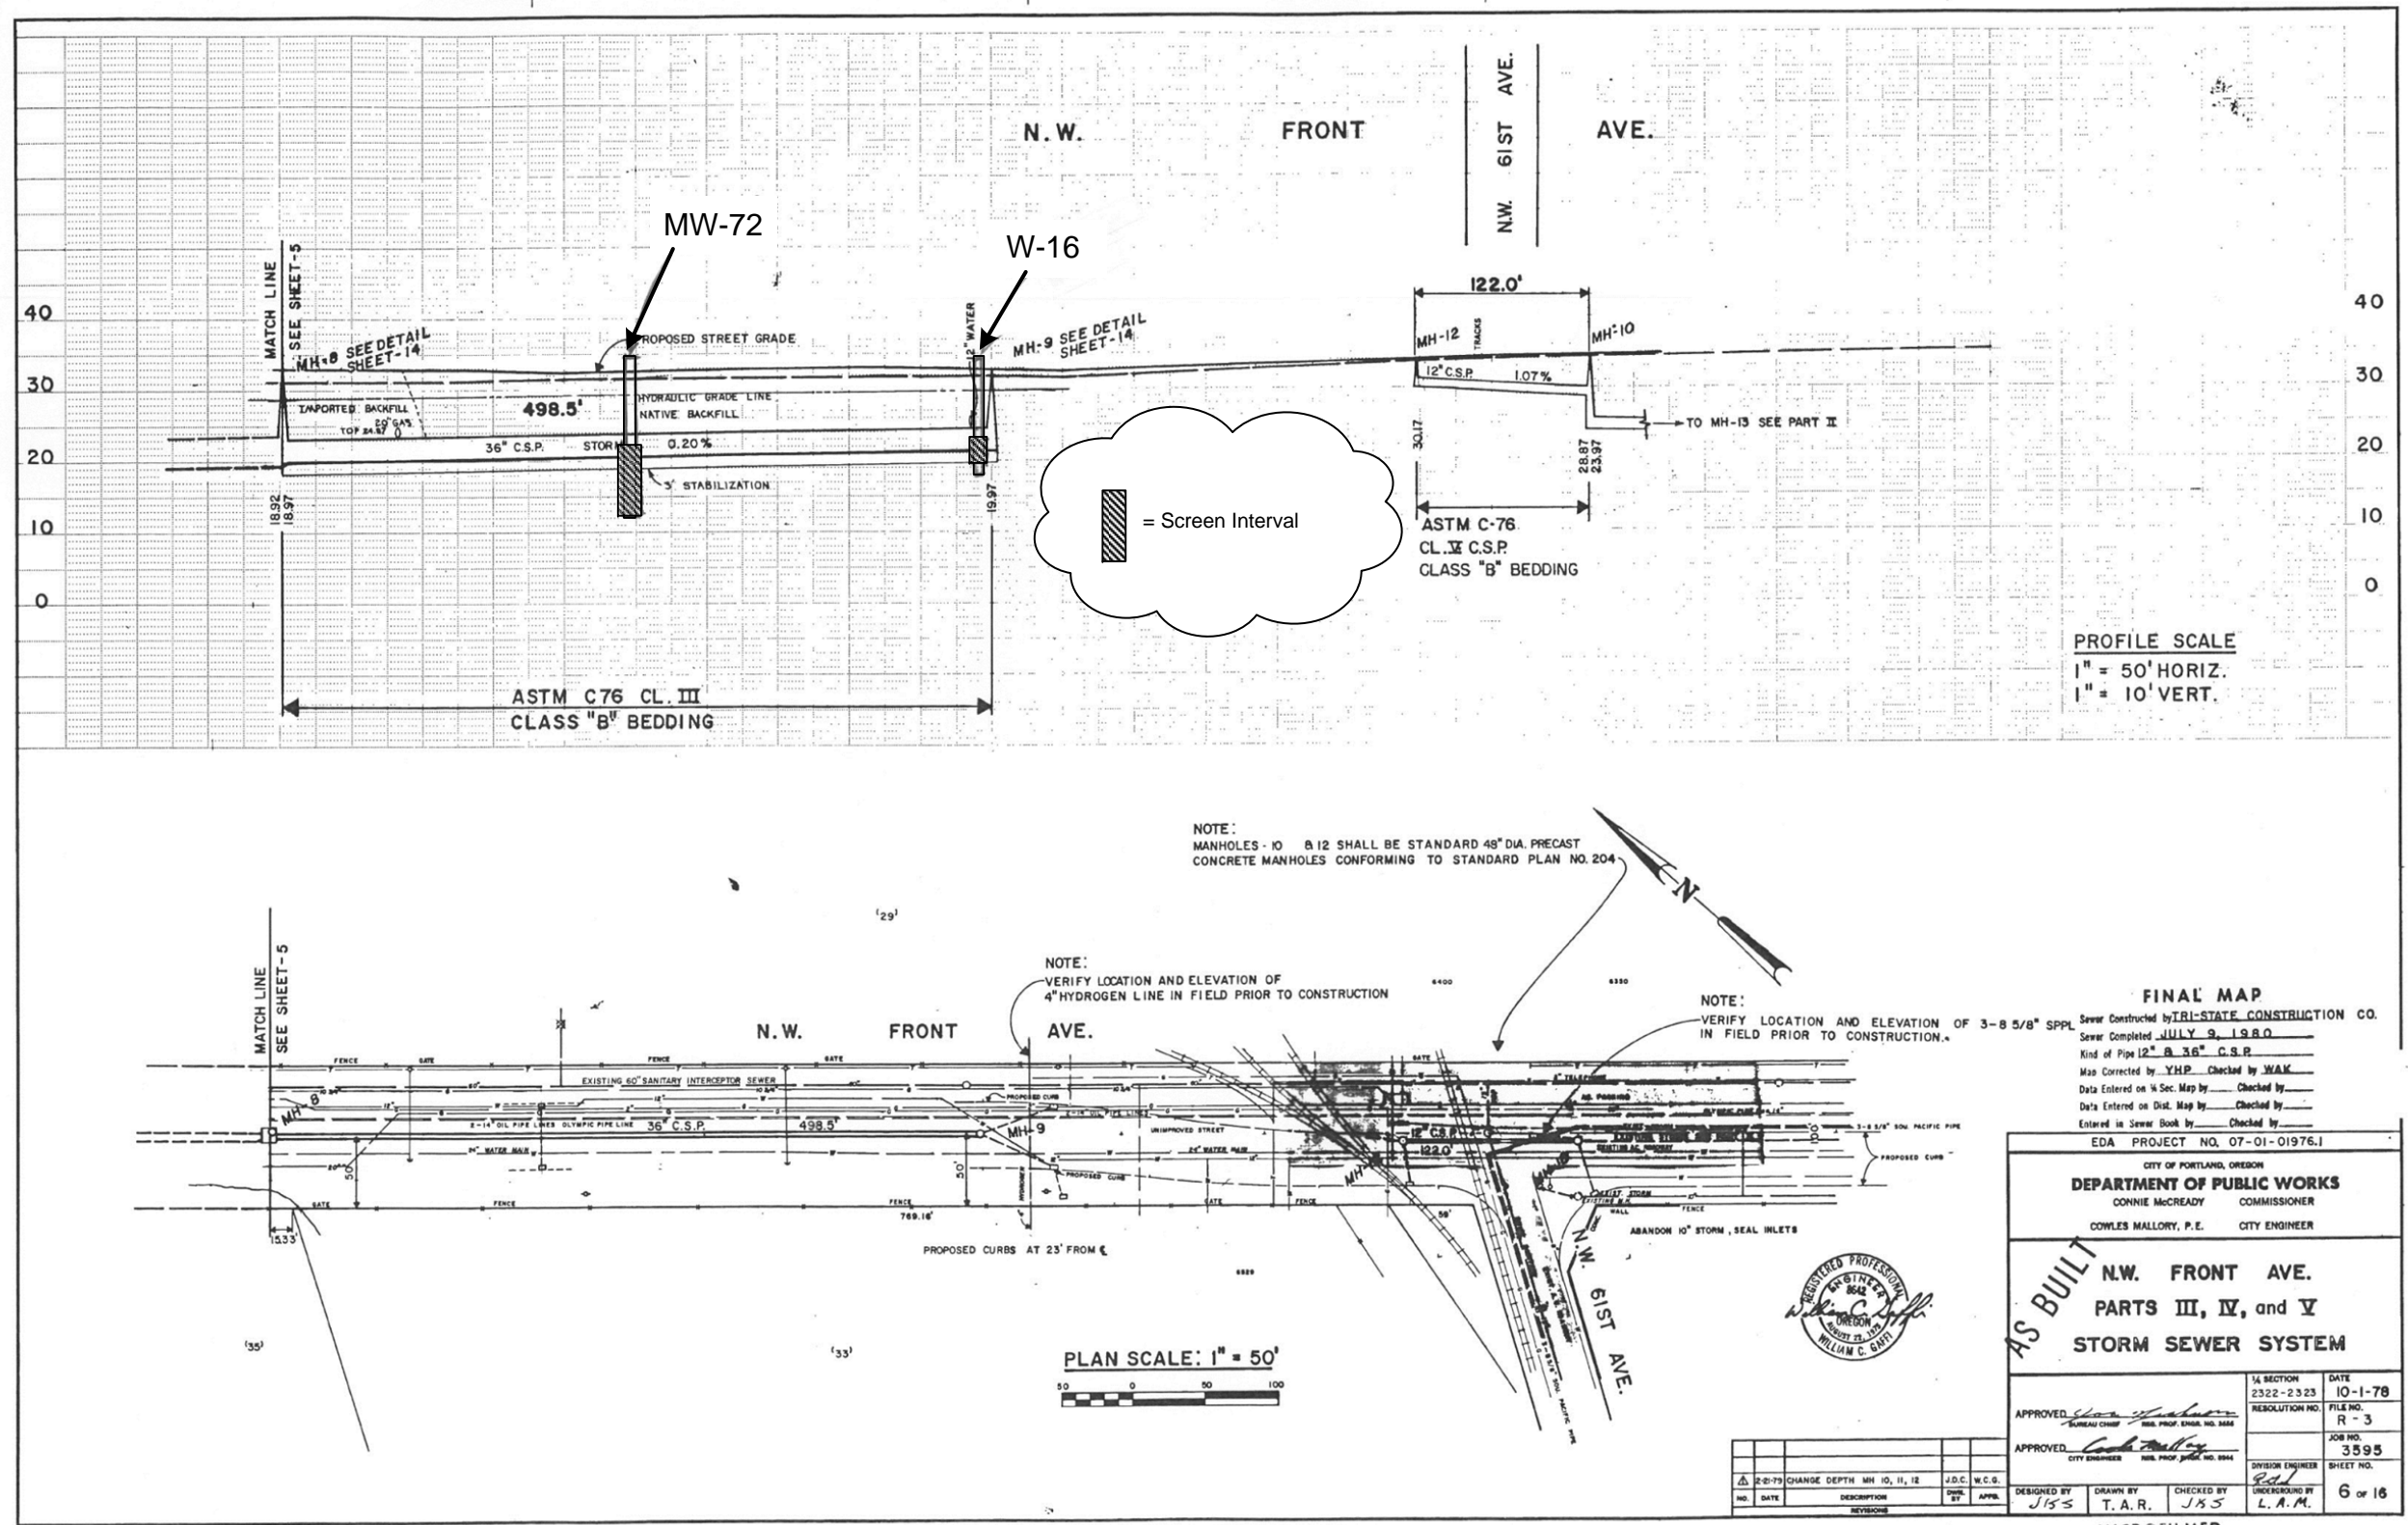
Figure 12
AS BUILT – N.W. Front Ave Parts III, IV, and V Storm Sewer System
SIC Doane Lake Property

Specifically as shown in Figure 12, the top of the OF-22B storm sewer pipeline at MH-08 (adjacent to the Site) is at approximately elevation 25 feet (approximately 9 feet bgs) which appears to be entirely in the fill/shallow zone. The pipeline is a 36 inch pipeline that ranges from elevation 20 to 25 feet (approximately) near the Site. Groundwater elevations at W-16-S(13) at the time of sampling (Oct 2009) was 30.45 ft. W-16 –S(16) is screened at elevation 20 to 25 feet (approximately). Monitoring well MWA-72 on the Arkema property is screened at elevation 12 to 22 feet. The groundwater elevation was 27.86 feet in August 2009.
